Brake cannot be assembled against frame - bolt cannot be tightened

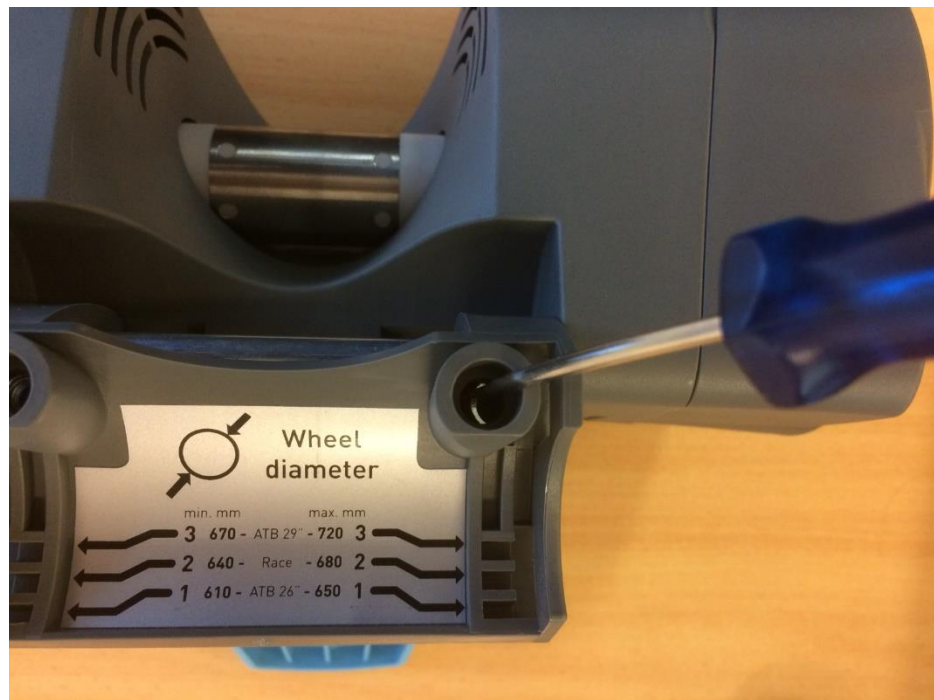
In this situation you see that the nut is not positioned correctly. With a flatbed screwdriver you can place the nut back in the middle position.

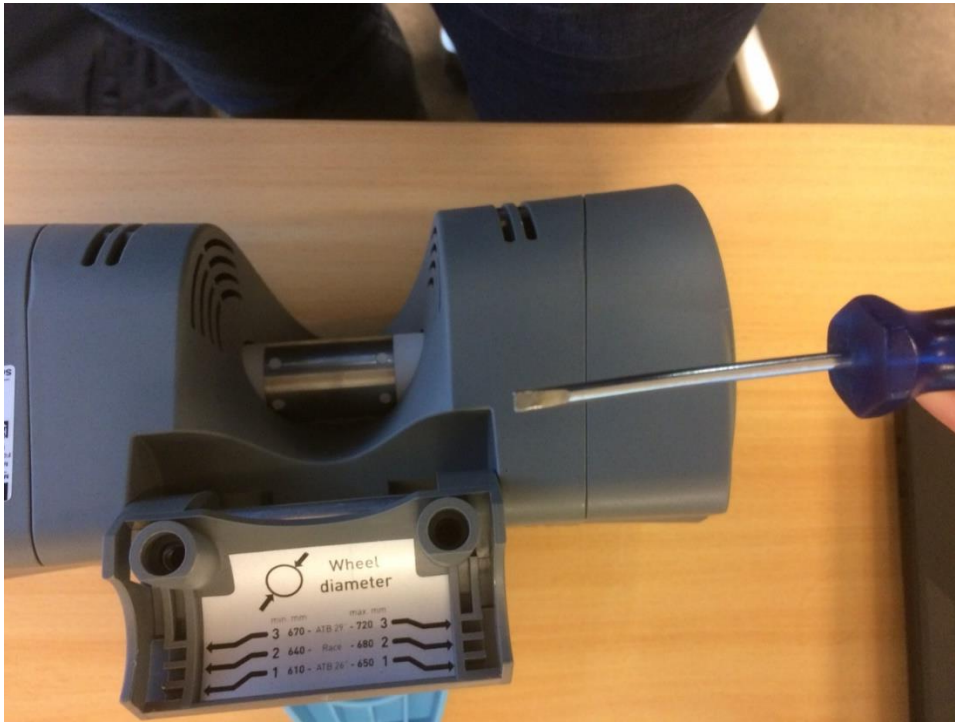
In this situation there is no nut in the Vortex brake

To add on (6mm) put the brake in the side position.
